**PROJECT:** Midnite Mine Remediation

**REPORT NO:** 2019-031

This weekly report provides a summary of Midnite Mine Site (Site) remediation action (RA) construction activities, quality assurance (CQA), quality control (CQC) and engineering activities for the period October 25 – 31, 2019. The Site activities discussed in this weekly report include, but are not limited to: Site Health, Safety, and Security; Community Liaison, Project Meetings, Regulatory Oversight, Site Visitors; Site Mobilization; RA Activities; Project Documentation; and Site Inspections.

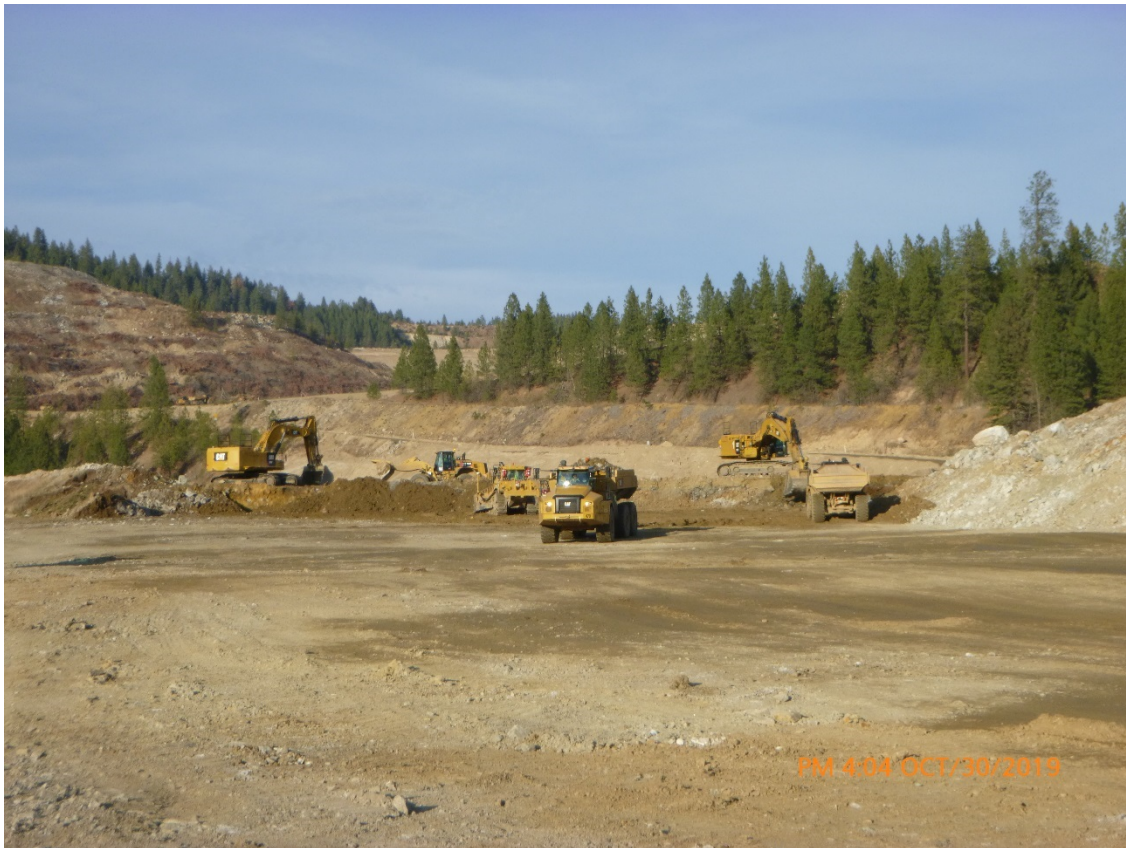
Figure 1 – Excavation of Low Activity/Low-Reactivity mine waste from west side of the SWRP, looking north.

- Continued excavating, hauling and placing low activity/low reactivity material to Pit 4 from the west and north sides of the South Waste Rock Pile (SWRP). Material from SWRP was placed in the Pit 4 Waste Containment Area (WCA).
- The above materials were excavated with either excavator or loader equipment and transported and plug dumped with haul trucks. The plug dumps were leveled with a dozer into lifts not exceeding 10' thick. Table 1 presents the 2019 Pit 4 mass haul material volume.

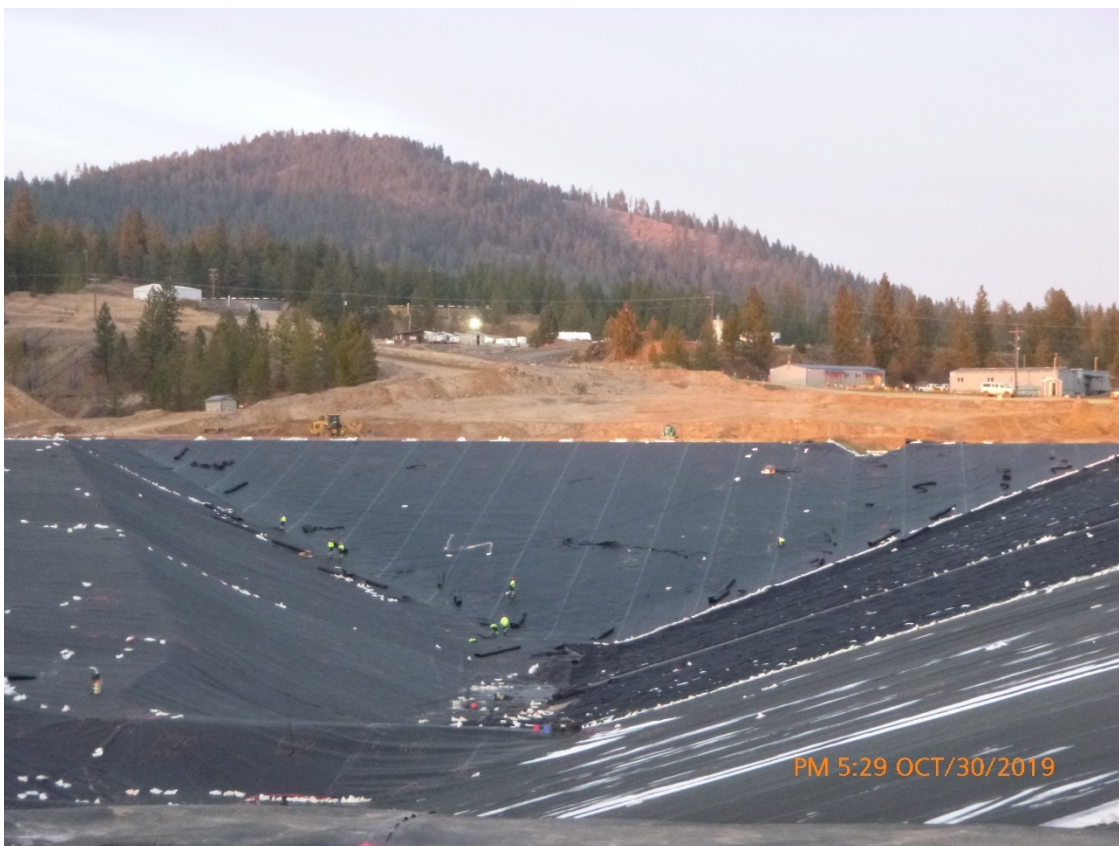
Figure 2 – AEG/Tetrattech installing the primary geomembrane liner on the east slope of the South Pond, looking northeast.

- Tetra Tech/AEG continued installation of the South Pond Liner System with support from Envirocon;
  - Continued installation of the Primary Containment Liner
